# EVALUATION OF POND WATER TREATMENT SYSTEMS

by  
R. D. Hill  
G. W. Malaney  
G. O. Schwab  
H. H. Weiser

OHIO AGRICULTURAL EXPERIMENT STATION  
Wooster, Ohio

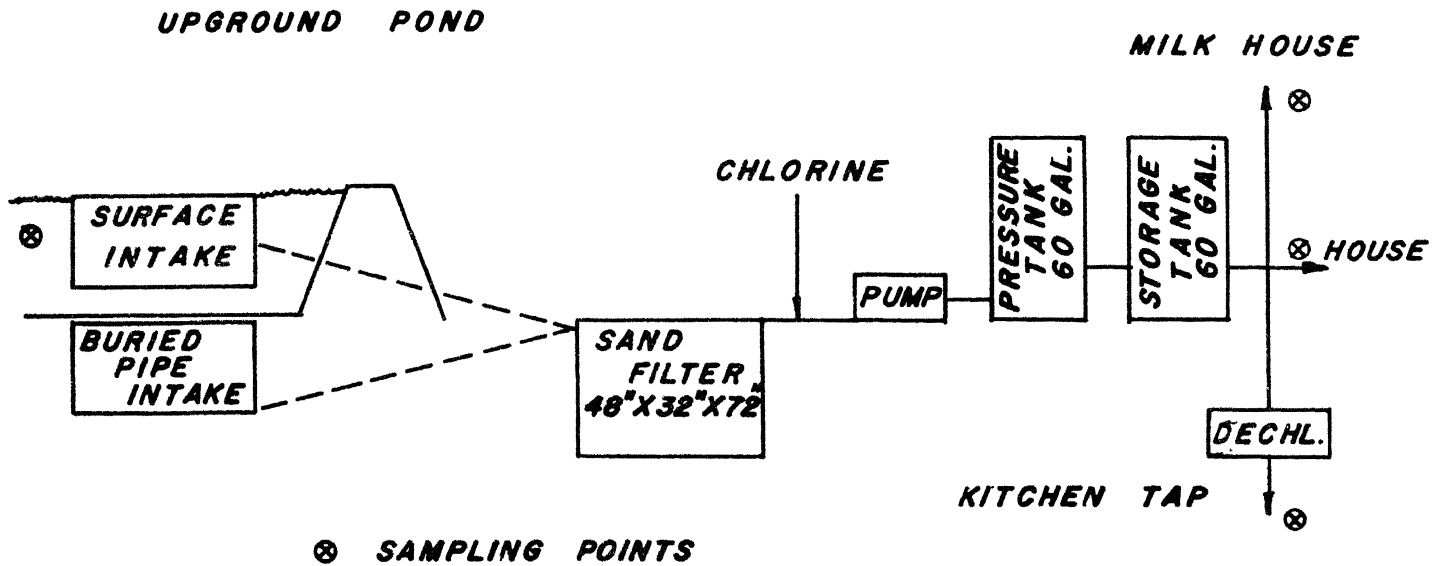
**FIGURE 2. FLOW DIAGRAM OF WATER TREATMENT SYSTEM  
INSTALLATION NO. 1**

A flow diagram of the water treatment system at installation 1 is presented in Figure 2. The buried pipe intake was constructed by digging a trench on the bottom of the pond, laying a perforated pipe in it and backfilling with gravel. This intake performed poorly as the water it removed from the pond was high in color. Complaints were made by the homeowner about the yellow color and about a precipitate that was formed when soap was used. Heating the water intensified the color. This condition disturbed the owners to the extent that they stopped using the pond water in the house. For this reason the buried pipe intake was replaced by a commercial fiber glass surface intake. This intake was composed of a replaceable fiber glass cylinder suspended eighteen inches below the pond surface from a float (Fig. 4). The fiber glass removed the larger solids, such as filamentous algae.

From information taken from Baumann (2) the chlorine contact time for this system was calculated to be approximately 3.6 minutes. The free available chlorine residual for 68 samples had a median value of 4.5 mg/l. Sixteen percent of the samples had no chlorine residual. This usually occurred when the chlorinator was broken.

Twenty-six of 60 effluent house samples showed the presence of coliform bacteria (Appendix A). In this report a MPN of less than 3.0 coliforms per 100 ml is considered to represent the absence of coliforms. In six of these samples the chlorine residual was zero; however, in only two were the numbers of coliform organisms excessive. The remaining samples although showing coliforms contained between 0.1 and greater than 16 mg/l of free available chlorine. According to a report by Baumann & Ludwig(3) under ideal conditions coliform bacteria represented by E. Coli in their study should be killed by 0.1 mg/l of free available chlorine with 3.6 minutes contact time. However, in twenty samples with greater than 0.1 mg/l of chlorine, coliform bacteria survived.

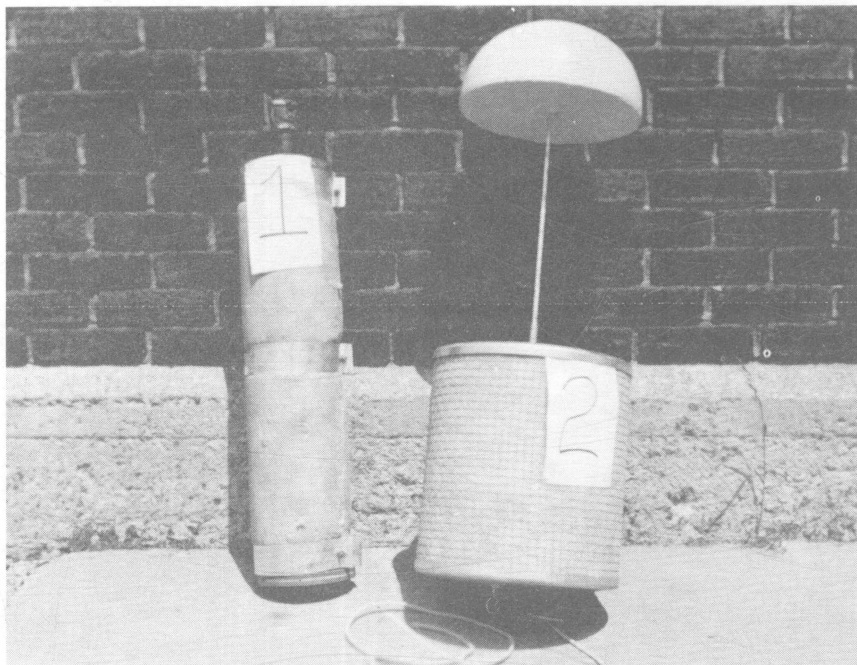
Figure 4. Surface Intakes: (1) one type of "homemade" intake which was supported by a 5-gallon can; (2) commercial intake.

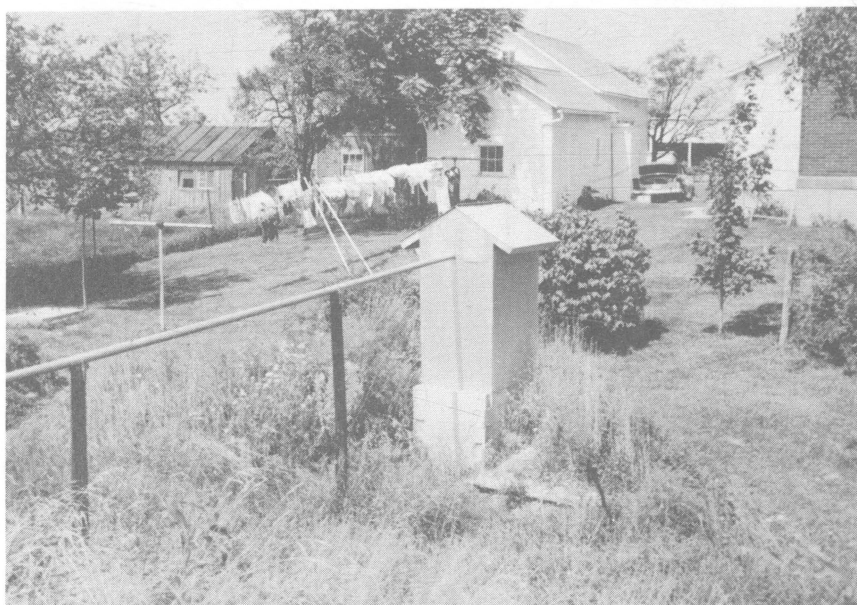
Figure 5. Installation 1: (1) on left hand side of picture the top of the slow sand filter can be seen. (2) Small stream from which water was pumped into pond is in front of pump house. Pipe line from pump house goes to pond.

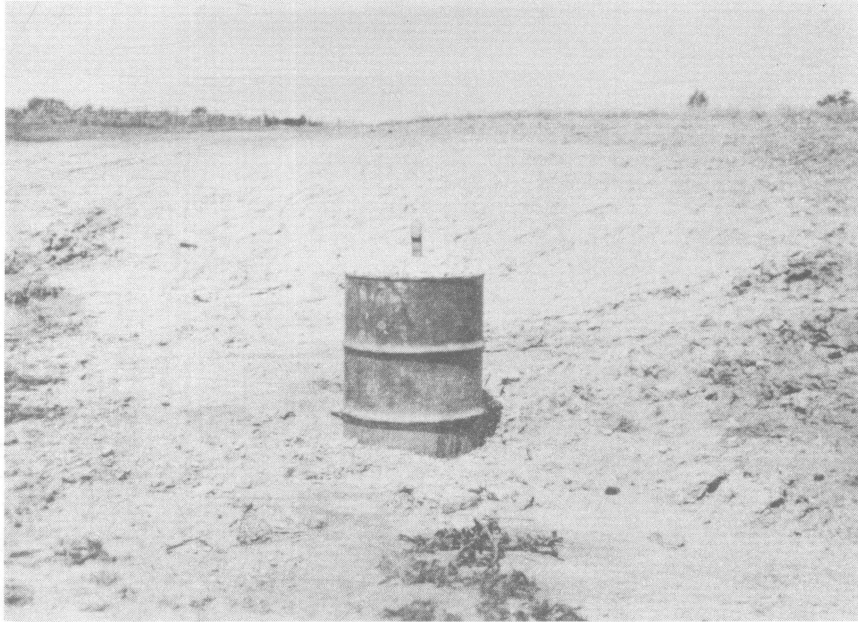
The barrel type inlet reduced the turbidity only slightly, and increased the color in 48% of the samples. This was probably due to the water picking up soluble organic substances from decaying algae and weeds that had settled into the intake. Although the average reduction of turbidity was 22%, only 52% of the samples actually showed a reduction in turbidity.

The barrel intake was the only equipment in this system capable of reducing the suspended solids in the water. The effluent from this intake, however, had a high concentration of turbidity and color as indicated in Appendix A. For this reason the owners replaced the barrel intake with a surface intake in July 1959. The surface intake was constructed from a section of perforated pipe wrapped with fiberglass sheet and screen. A galvanized pipe was driven into the bottom of the pond and the intake attached to it.

Figure 6. Typical barrel type intake. Such intakes are normally two drums high. (Photo courtesy Soil Conservation Service)

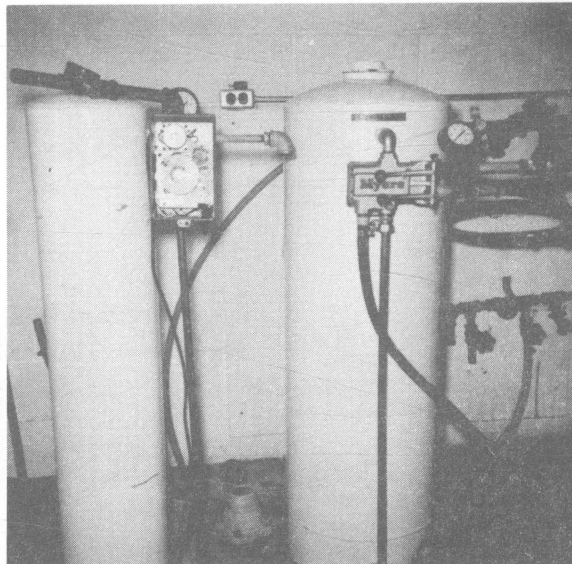
Figure 7. Typical pressure sand filters. Many companies manufacture filters similar to these with the major difference being the backwash mechanism. Filter on left is automatically backwashed and filter on right, manually.

The pressure rapid sand filter was 12 inches in diameter (Fig. 7). It was a standard water conditioner tank with sand instead of exchange resin for filter medium. According to the manufacturer's literature, this filter should have contained 50 pounds (dry weight) of gravel and 42 pounds of sand and have a maximum flow rate of 2.5 gpm and a minimum backwash rate of 6 gpm. The home owner reported that the filter was backwashed every couple weeks for 10 minutes and then rinsed for five minutes. From observations made at installation 8 and elsewhere, it would seem that more frequent and longer periods of backwashing would be needed to clean this filter. It is also rather doubtful that the recommended flow of 6 gpm was available for backwashing. The maximum flow through the filter registered a maximum of 2 gpm, or 1.56 gpm per square foot surface area, i.e., below the 2 gpm per square foot commonly recommended for rapid sand filters.

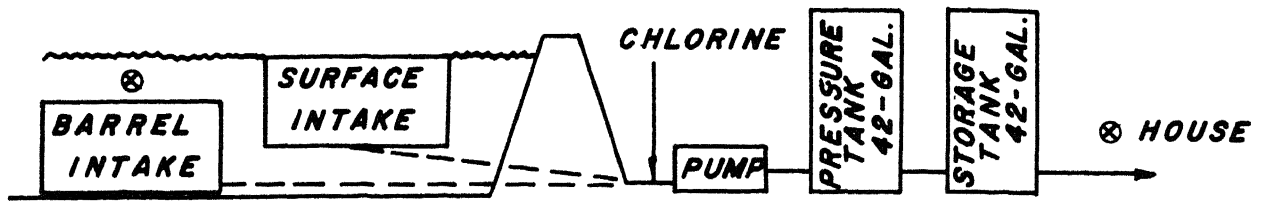
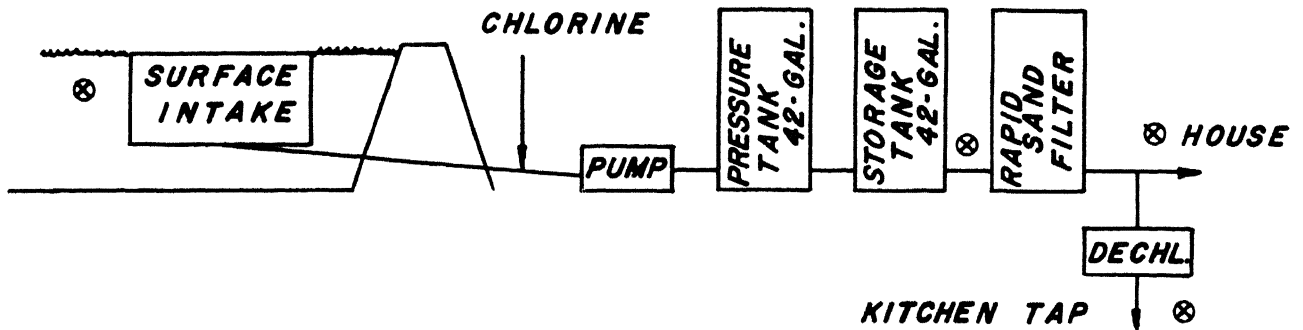
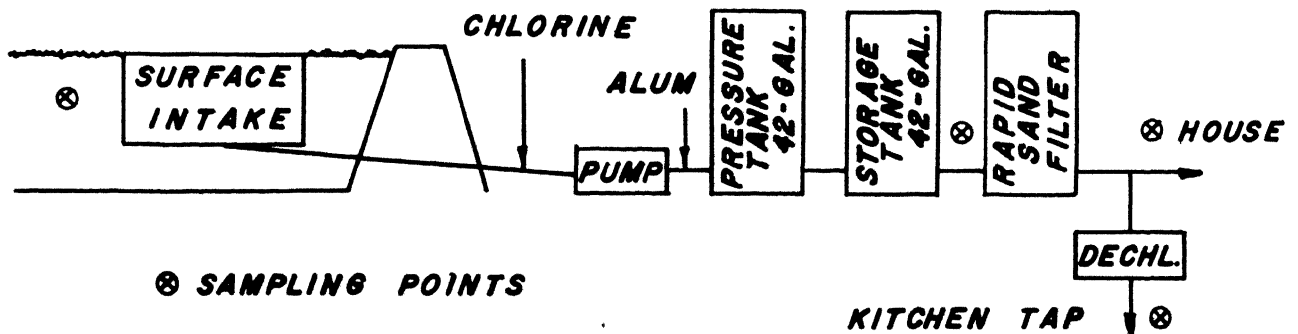
**FIGURE 8. FLOW DIAGRAM OF WATER TREATMENT SYSTEMS  
INSTALLATION NO. 8**

The poor quality of water being obtained in the house prompted the owners to improve their system. In May 1960, a pressure rapid sand filter and dechlorinator were added to the system (Fig. 8). The exchange media of a second hand water softener was replaced with filter sand having an effective size of 0.52 mm and uniformity coefficient of 1.5 (Fig. 7). The filter was 16 inches in diameter and had a valving system for backwashing. The dechlorinator was of the precoated carbon type.

In February 1961, the "homemade" fiber glass intake was replaced by a porous ceramic filter (a). The ceramic unit was 8 inches long and  $3\frac{1}{2}$  inches in diameter with a filtering area of 106 square inches. It was suspended 1 to 2 feet below the surface. The owners cleaned the unit by removing, washing, and drying. A second unit was used while the first was being cleaned.

On January 20, 1962, a diaphragm chemical pump was installed to feed alum to the system between the pump and pressure tank. The alum supply was a slurry formed by adding 12 pounds of alum to 48 gallons of water (30,000 mg/l) in a plastic tank. The foot valve of the pump was attached to a float in the plastic tank so that sediment would not clog the pump.

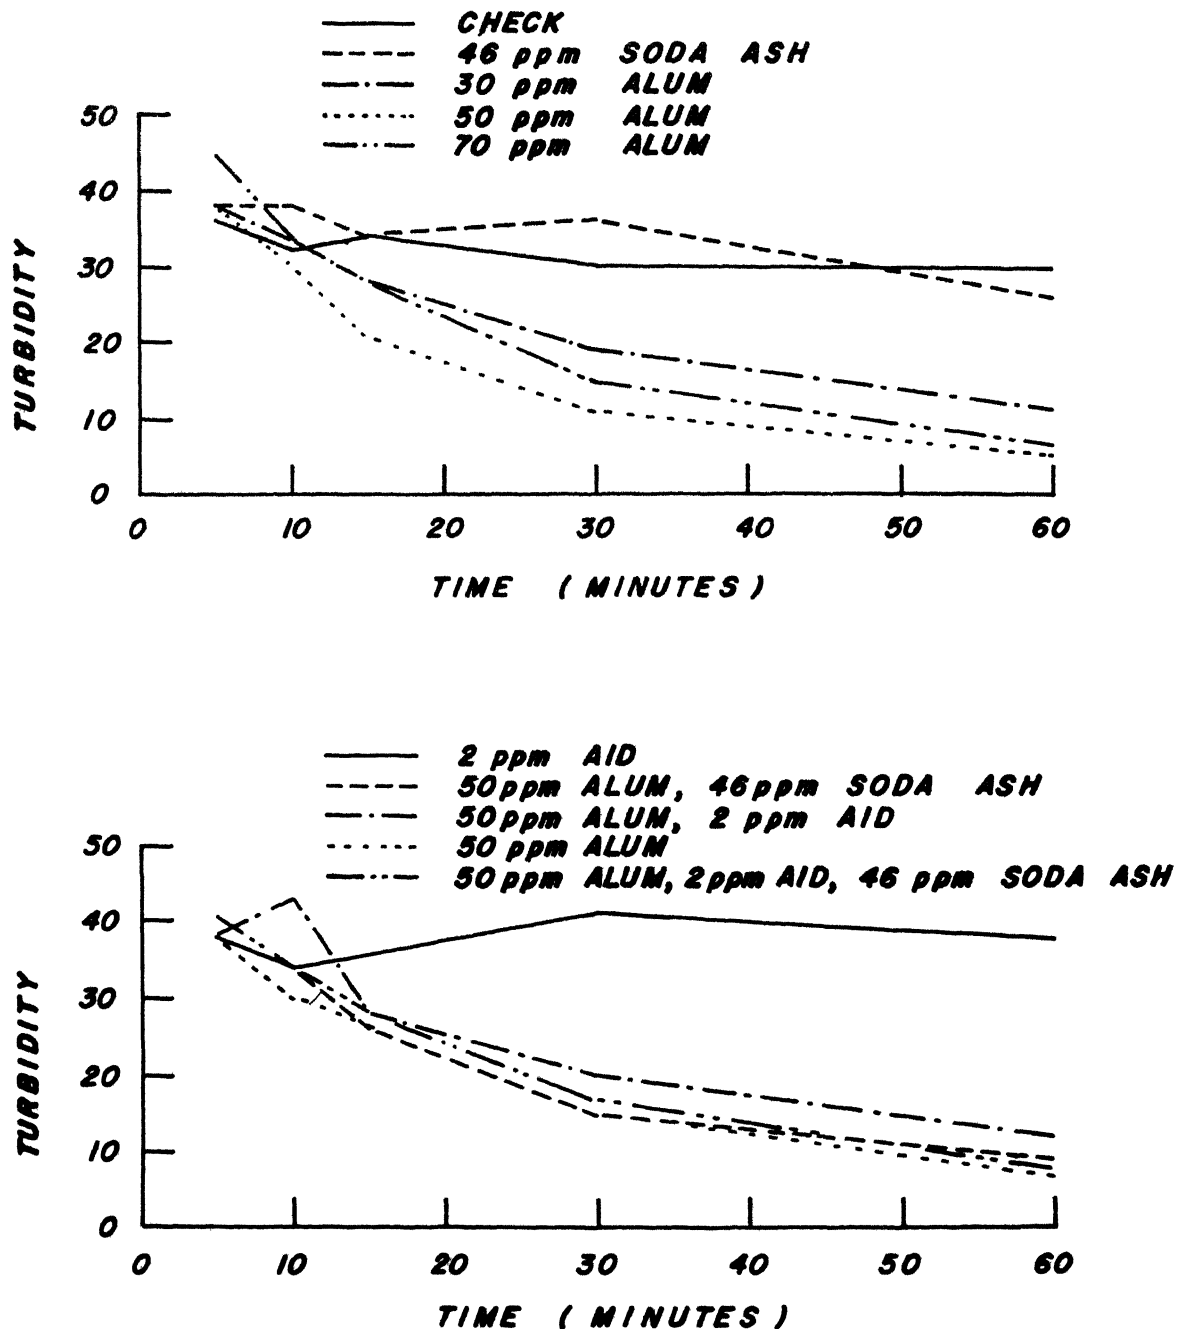
FIGURE 9. FLOCCULATION AND SEDIMENTATION STUDIES  
 INSTALLATION NO. 8

Tests made at the installation indicated that an alum dosage of 80 mg/l produced the best quality water. Approximately 0.3 gallons of alum slurry was fed per day. The addition of the alum increased the turbidity and color of the filter influent above the concentrations found in the pond. However, the filter was able to remove 82% of this turbidity and color. The effluent water contained 44% less turbidity and 58% less color than the raw pond water. On three occasions the turbidity did not meet the Standard (8). In two of these cases the alum dosage was probably not sufficient, as indicated by the small increase in turbidity of the filter influent.

This method then showed some improvement over the filter without pretreatment. One disadvantage noted was the lowering of the pH from approximately 8.0 to 7.1. On a few occasions it was lowered below 6.8. Further research is needed to improve this method which appears to be an essential requirement if the pressure rapid sand filter is to be made suitable for domestic water systems.

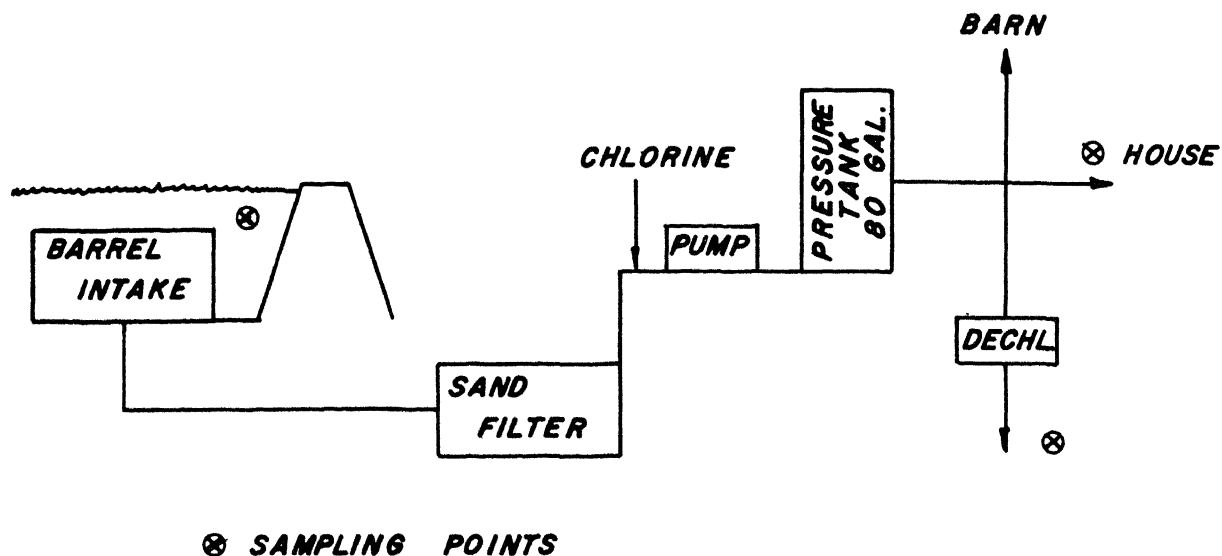
**FIGURE 10. FLOW DIAGRAM OF WATER TREATMENT SYSTEM  
INSTALLATION NO. 23**

The raw water at installation 23 had the highest turbidities of any pond studied (5). The turbidity was composed of fine clay which did not settle easily, and was difficult to flocculate because of the low pH (between 5 and 7) and alkalinity (avg. 8 ppm) of the water. The small clay particles also made the turbidity difficult to filter. The bacterial population of the water was also higher than that found in most Ohio ponds.

This definitely indicates that a rapid sand filter of this type with no pretreatment, such as flocculation, and with an inadequate backwashing system is not effective in filtering pond water. The filter probably would have operated with better success if a water storage tank had been provided after the filter and the flow rate through the filter reduced to the range normally used in slow sand filters.

The contact time between the chlorine and water was calculated to be 9.8 minutes. The majority of the contact took place in 300 feet of pipe running from the pump to the house. The Ct factor ranged between 0 and 147. Seven of the 24 samples tested after chlorination were found to contain coliform bacteria. Four of the contaminated samples occurred when the chlorine residual was so low that a Ct factor at which coliform bacteria would be destroyed was not reached. Three samples showed coliforms even though they had a Ct factor of 39, 39, and 54. The high coliform density in the July 1960 sample indicates that this sample was probably contaminated after being taken. The remaining two contaminated samples might have resulted from the bacteria being entrapped in sediment and, therefore, protected from the chlorine. Even this does not seem likely at very high Ct factors and other factors may be involved.

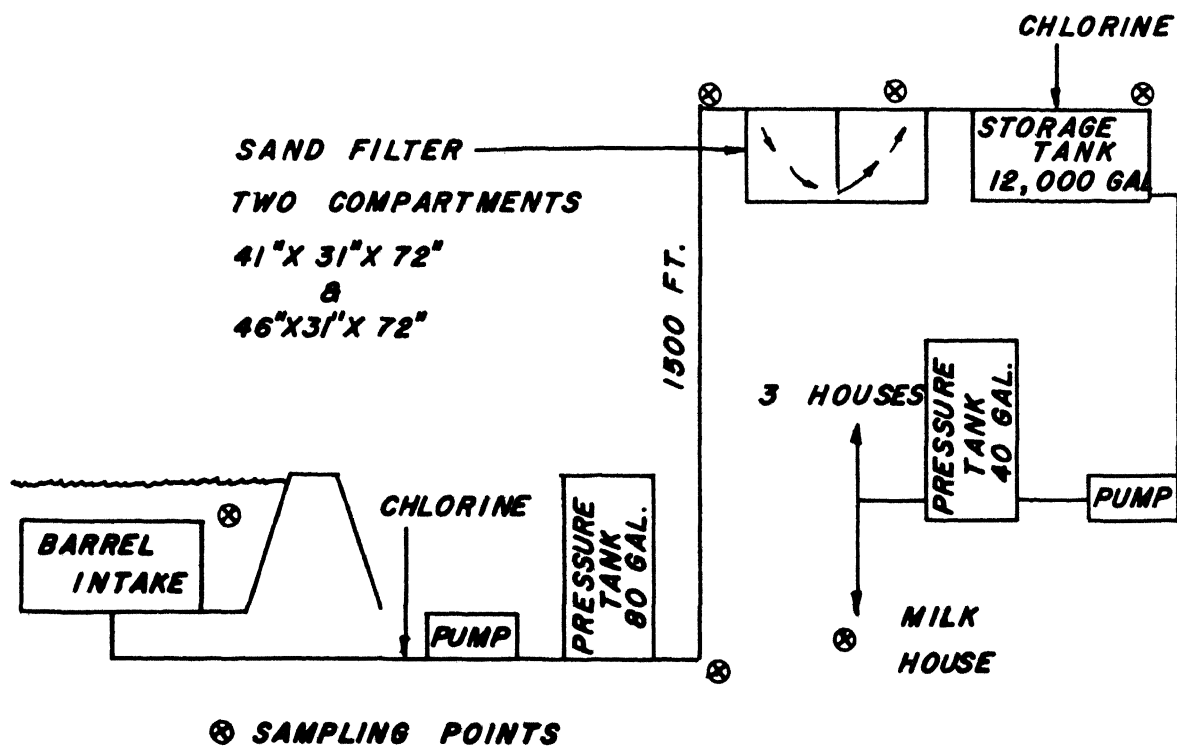
**FIGURE 11. FLOW DIAGRAM OF WATER TREATMENT SYSTEM  
INSTALLATION NO. 25**

The water treatment system at installation 25 is illustrated in Fig. 11. During part of this study, chlorine was fed to the water before the pump at the pond. Water flowed by gravity through the filter to a storage basin. A second pump supplied water to three houses, a milkhouse, and livestock.

The filter was constructed as a slow sand filter, but actually was operated as a rapid sand filter since the flow rate ranged from 175 to 610 gallons per day per square foot of surface area. The filter had two compartments with the flow passing down through the first and up through the second (Figs. 11 & 13). Cleaning was accomplished by replacing the sand and gravel once or twice a year. At times charcoal was also added with the sand and gravel. Due to the heavy water demand, the filter operated continuously.

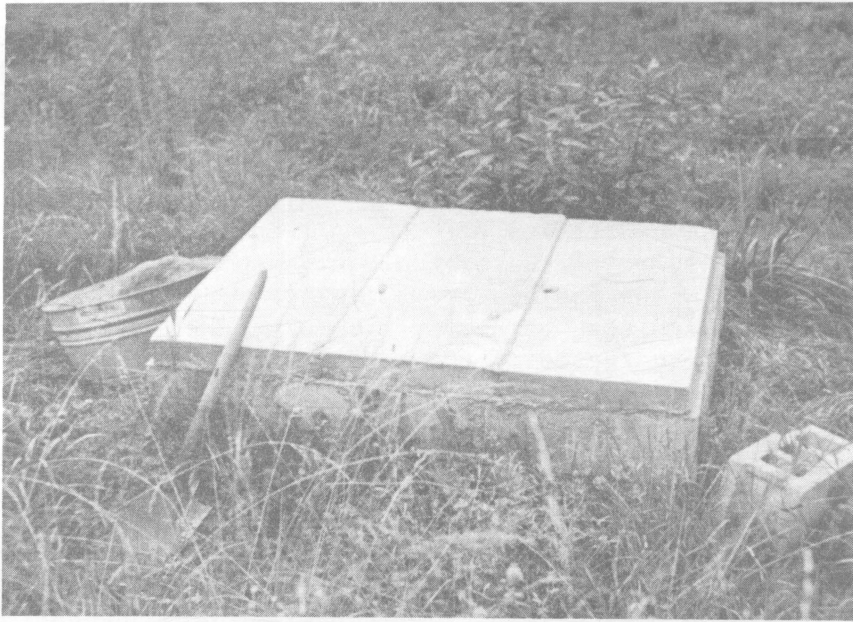
Figure 12. Installation 23. Sand filter located at foot of dam. Water flowed to filter by gravity.

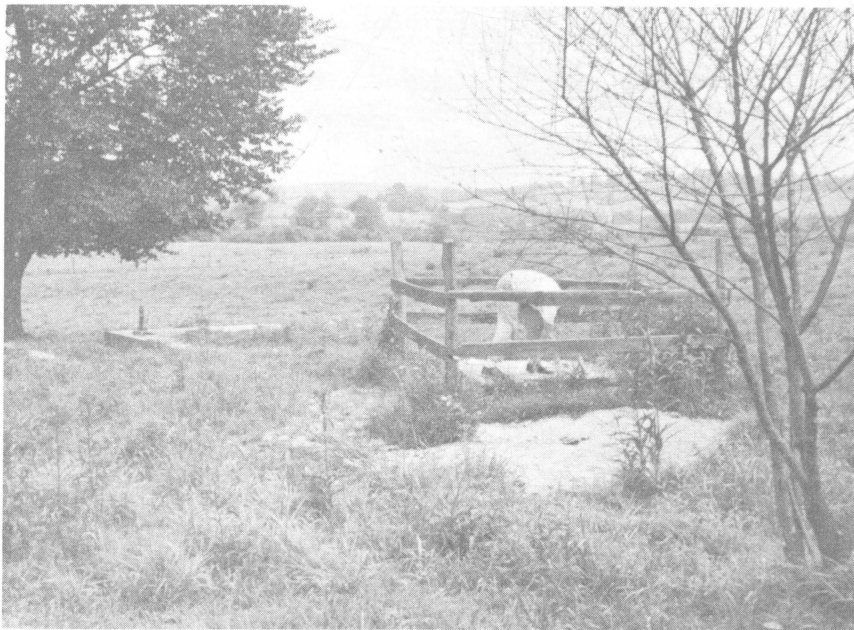
Figure 13. Installation 25. Sand filter located inside wooden fence. Clear well can be seen to the left of filter. Note that both are in a pasture and that only the filter is protected from livestock.

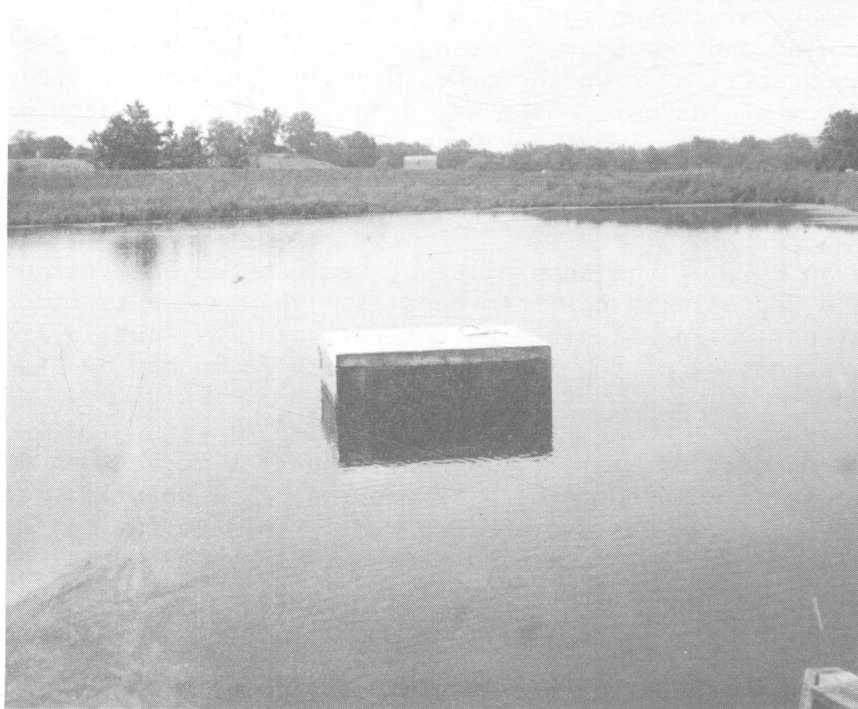
Figure 17. Installation 62. Block box intake. This intake contained no gravel.

During the course of this study the mortar between some of the cinder blocks had come out leaving an open channel to the inside of the intake. This finding placed serious doubt as to whether or not the blocks were filtering the water. It was theorized that the box was acting as a settling tank, since the inside of the box was not affected to any great extent by wind and temperature changes, resulting in a condition favorable to good settling. On the other hand, no buildup of sludge appeared in the bottom of the box. However, since the effluent pipe was near the bottom of the box, sediment may have been drawn into the water system. This effect is indicated in some sample sets where the turbidity was higher in the house than in the intake.

Only in half of the sample sets taken outside and inside the intake was there a decrease in coliform density. This suggests that the intake was not effective in reducing the coliform density, but in light of the defective structure of the box, not too much faith can be placed in this conclusion.

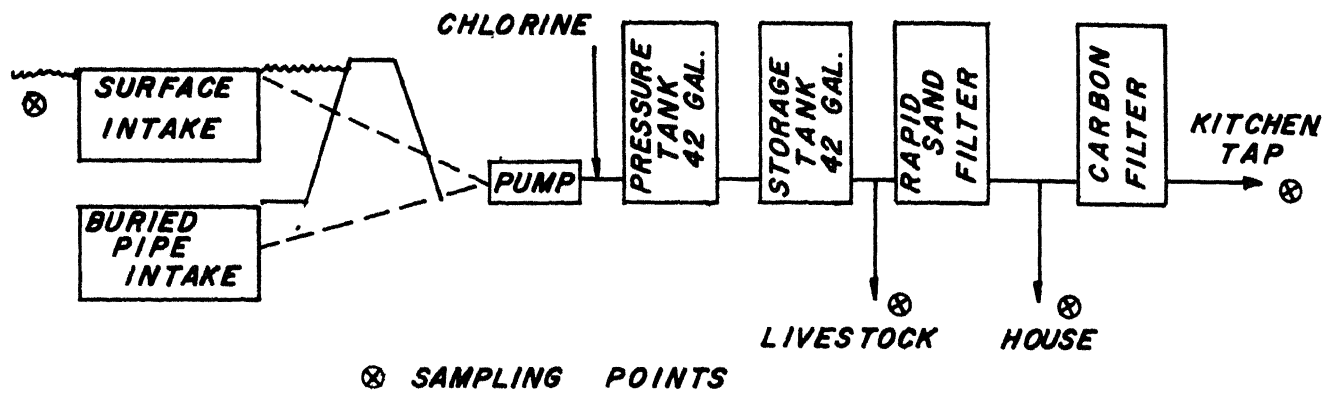
**FIGURE 22. FLOW DIAGRAM OF WATER TREATMENT SYSTEM  
INSTALLATION NO. 90**

A section of perforated plastic pipe placed inside agricultural tiles and buried under two feet of gravel in the bottom of the pond was used as an intake at this installation. This was replaced in September, 1959, by a surface type intake (Fig. 23). Water was pumped from the intake and chlorinated in the basement of the house. A Wallace & Tiernan diaphragm pump-chlorinator was used to add household bleach to the water. This was later replaced (Aug. 1959) with a BIF Industries diaphragm chlorinator. Two tanks of 42-gallon capacity each (one a pressure tank and one a storage tank) followed the pump. Water for the livestock received no further treatment, while that used for domestic purposes passed through a pressure rapid sand filter. Water used in the kitchen received further treatment through an activated carbon filter. Water used elsewhere in the house did not receive this treatment (Fig. 22).

The pressure rapid sand filter at installation 90 was similar to  
that at installations 88 and 89, but was made by a different manufacturer  
(Fig. 7). This filter was 15 inches in diameter and the manufacturer  
recommended a maximum flow rate of 8 gpm and a backwash rate of 10 gpm.  
The highest recorded flow rate was 5.25 gpm (4.3 gpm per sq. ft. surface  
area). The homeowner reported that he backwashed the filter monthly.

The activated carbon filter following the sand filter was 11 inches  
in diameter and had a recommended flow rate and backwash rate of 4 gpm.  
This filter contained  $\frac{1}{4}$  to  $\frac{1}{2}$ -inch granules of activated carbon and was  
backwashed on the same schedule as the sand filter.
